MCFRS In-Service Training Program

BASEMENT AND CELLAR FIRES

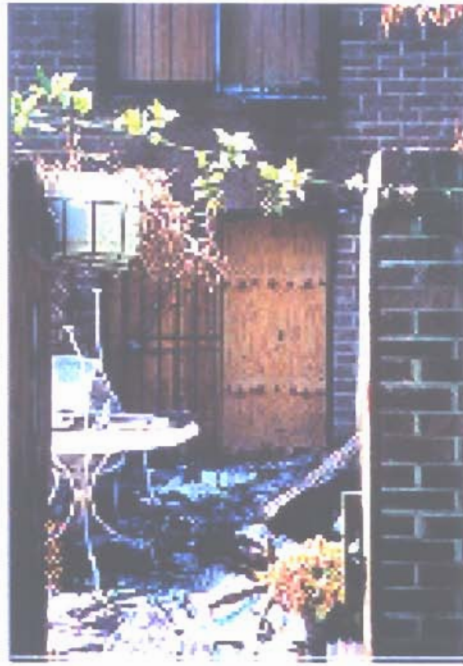
Photo 2: *This photo depicts the rear (side 3) sliding-glass door leading to the basement*

Engine 17 was now positioned at the rear sliding-glass door as Truck 4 prepared entry (basement level). Using a gas-powered saw and a sledge hammer, the officer and fire fighter from Truck 4 removed the iron security gate and broke open the glass door at 0026 hours (see Photo 2). Members of Truck 4 and Engine 17 stated that when the sliding-glass door was opened, air began to be sucked inside by the fire. They also saw small fires on the floor and stated that when the door was opened the fires grew larger. The Lieutenant from Engine 17 reported to the IC that they had fire on the first floor and requested permission to hit the fire. *[NOTE: Engine 17 was unaware that they were at the basement level due to the route they took to get to the rear. As they proceeded to the rear, they noticed the row houses they went between were only two stories, which caused confusion (see Diagram 1).]* The IC denied their request in fear of opposing hose lines. He then radioed the officer from Engine 26 to locate their position. He received no response from them. The IC knew that the crews from Engine 26 and Engine 10 had entered through the front door on the first floor.

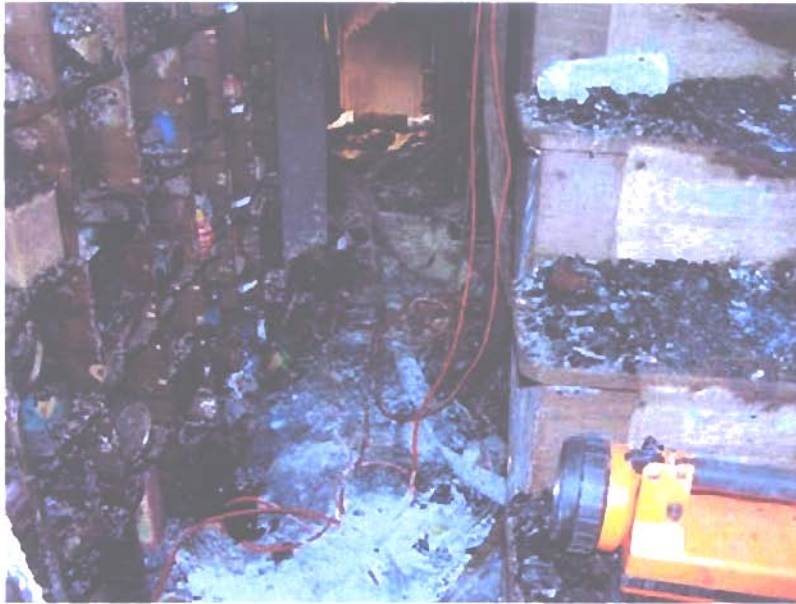
Photo 1. Narrow hallway at bottom of basement stairs.

(See [Photo #1](#)). Visibility was still good in the basement at this time. The DC opened a door to a room and there was minimal heat as the smoke banked down approximately 8 to 10 inches below the ceiling. The fire was sluggish along the ceiling coming from the C/D corner of the structure (see [Diagram](#)). The fire was in the suspended ceiling system overhead extending out from the C/D corner. *Note: This ceiling system would allow the fire to spread and gases to build up undetected in the void space overhead.*

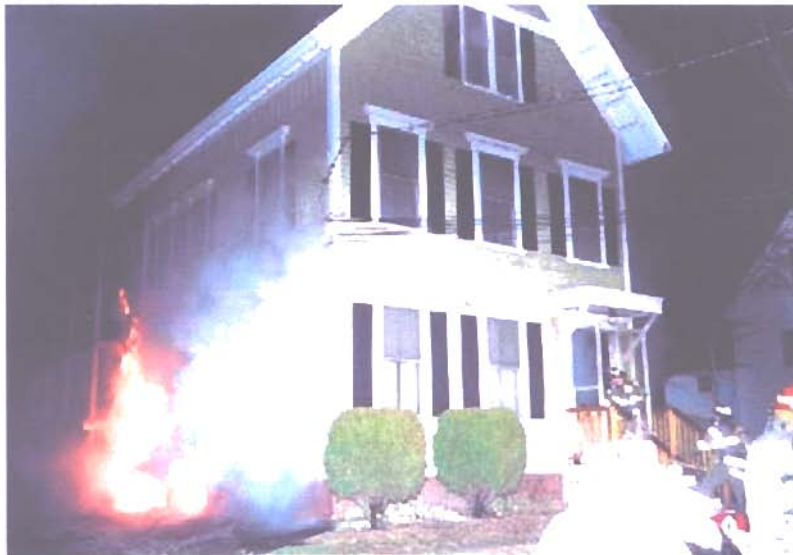
Photo 2. B-side basement windows engulfed in flames.

The Lieutenant and two fire fighters from E5 had just made their way down to the first floor when fire fighters exiting the basement stated that a fire fighter was still in the basement. The crew from E5 immediately went to the basement. One fire fighter stayed at the bottom of the stairs as the Lieutenant and the other fire fighter searched for the victim. The Lieutenant yelled for the victim to manually activate his PASS with no response. They followed the hose line searching for the victim. Debris was falling on them and debris covered the basement floor and most of the hose line as they searched for the victim. Blue flames approximately two feet thick rolled across the basement ceiling. *Note: It is believed that two of the gas meters began to fail at this time due to the fire conditions.* The Lieutenant found the victim who requested assistance as he was trying to crawl without his mask. The Lieutenant yelled to his fire fighter for assistance. The fire fighter arrived within seconds to assist the victim who was now unresponsive. The two had great difficulty trying to drag the victim to the stairs due to the mounds of debris. Once they got the victim to the stairs they both called for Mayday without any response. As they were attempting to move the victim up the stairs, the basement became engulfed in flames (see [Photo #2](#)) and they were forced to leave.

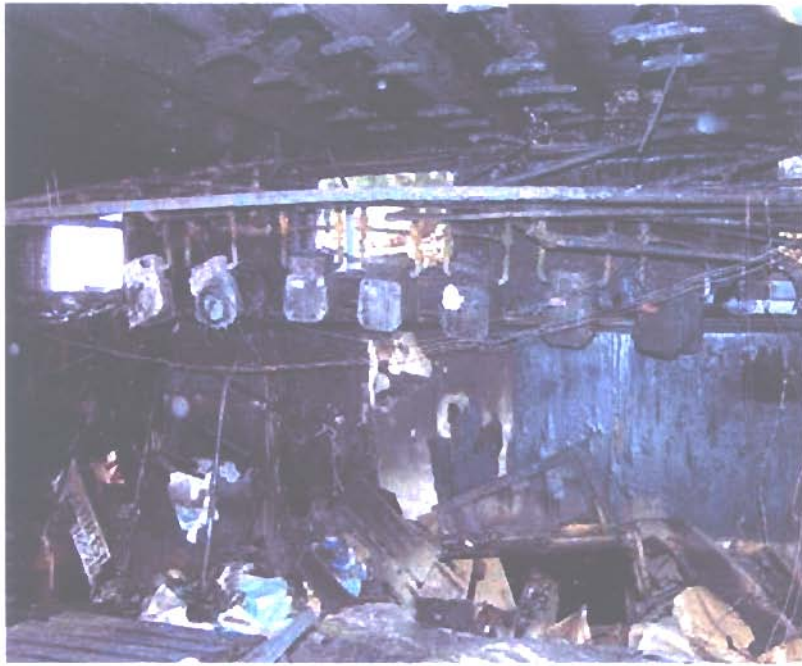
Photo 3. The two compromised gas meters are on the left.

Fire conditions in the structure became untenable. *Note: At least two gas meters in the basement were compromised by the fire increasing the fire load (see Photo #3).*

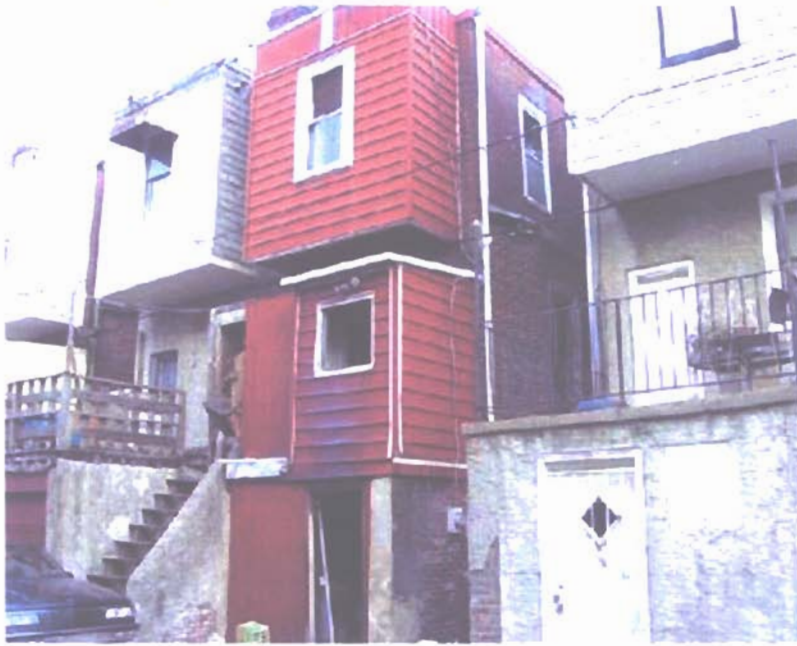
Photo 1. Rear of structure

E51 and L22 were operating at the rear of the structure with the IC. L22 was assigned search and rescue, while E51 made entry into the basement through a door at ground level (see [Photo 1](#)). Entry was impeded approximately 10 feet inside the basement door due to an old appliance and debris which was stacked about five feet high over the entire basement floor (see [Diagram 2](#)).

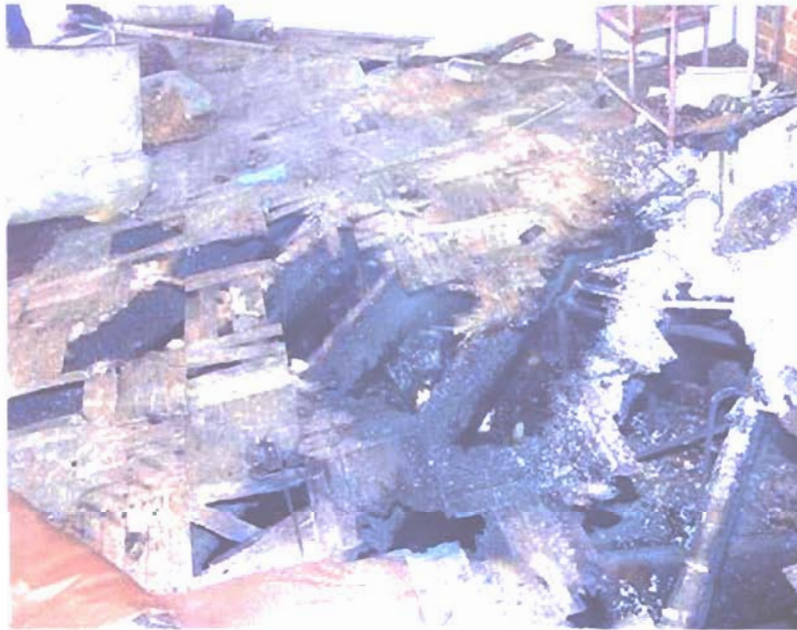
Photo 2. Floor area consumed by fire

smoke out of the window. At 0643 hours, the victim responded "That's affirmative, we can do that." The victim turned around to exit the first floor and tripped over the hand of one of his fire fighters and stumbled towards the front door. Fourteen seconds after his last transmission, the victim keyed his radio for 4 seconds without speaking. *Note: The victim did not make it out of the structure. It is believed that the victim's foot fell through the floor at this time (see [Photos 2 and 3](#)).*

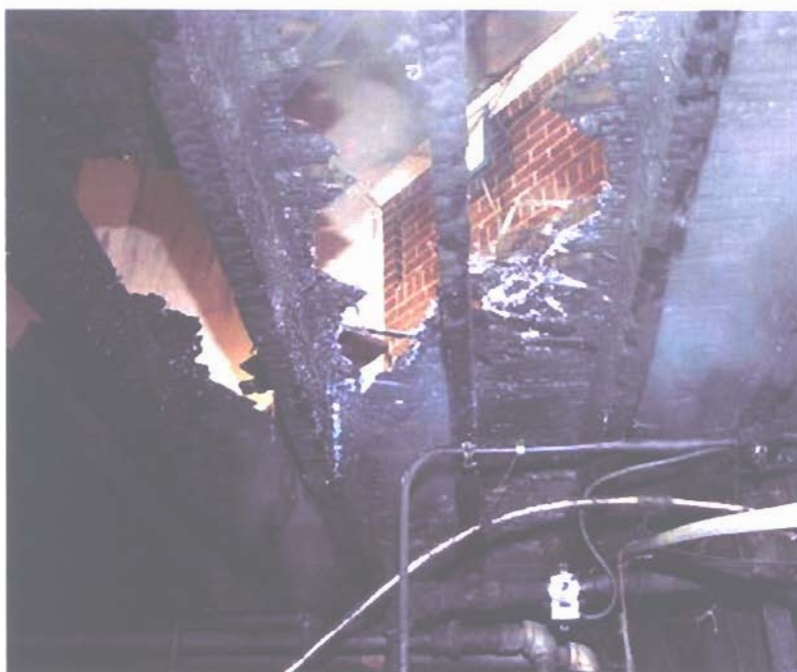
Photo 3. View from basement of floor area consumed by fire

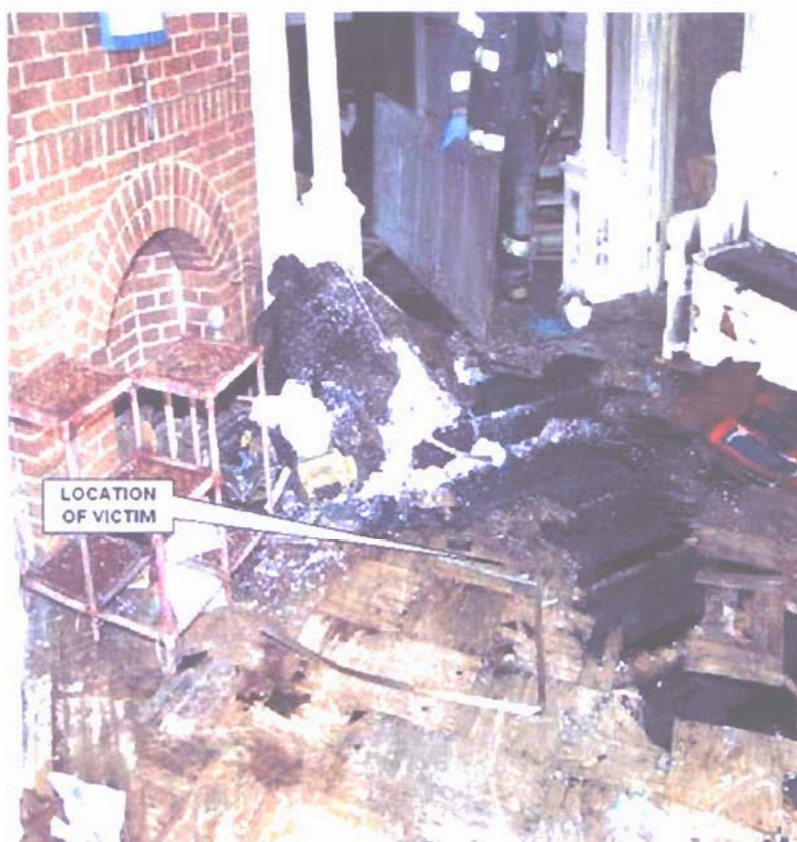
Photo 4. Living room floor
